**Flood Control Project Maintenance  
Levee Inspections**  
**2009 Channel Summary Report**  
**Overall Unit and Item Ratings**

**Adin Community Service District**

**Flood Control Project Maintenance**  
**Unit Cover Sheet**  
**2009 Channel Inspection Results**

**Flood Control Project Maintenance  
Channel Inspections**

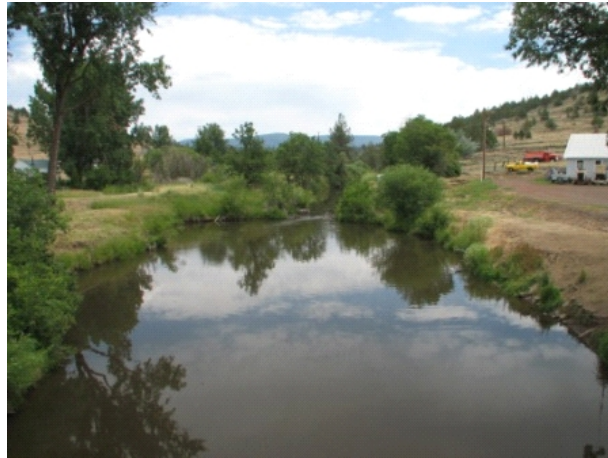
Levee Mile Report Line	1
Start Levee Mile	0.00
End Levee Mile	0.00
Location	
Category	Channels
Item	Vegetation & Obstructions
From Main Street (Highway299) towards the gauging station	
rduffey_c_20090817_002.jpg

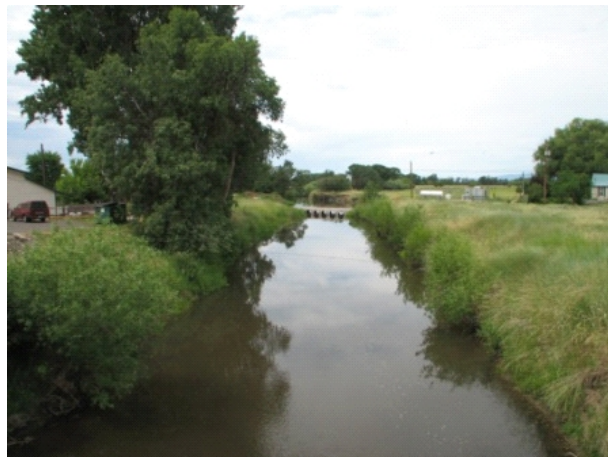
Levee Mile Report Line	1
Start Levee Mile	0.00
End Levee Mile	0.00
Location	
Category	Channels
Item	Vegetation & Obstructions
From Main Street (Hwy. 299) at the Ash St. low water crossing	
rduffey_c_20090817_003.jpg

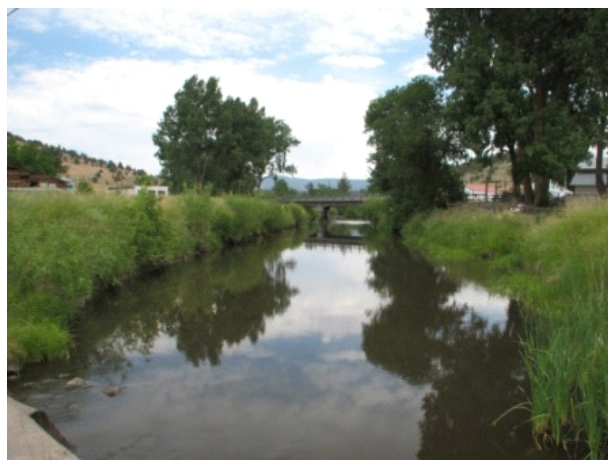
Levee Mile Report Line	1
Start Levee Mile	0.00
End Levee Mile	0.00
Location	
Category	Channels
Item	Vegetation & Obstructions
From Ash Street Moderate tree growth and bank erosion	
rduffey_c_20090817_004.jpg

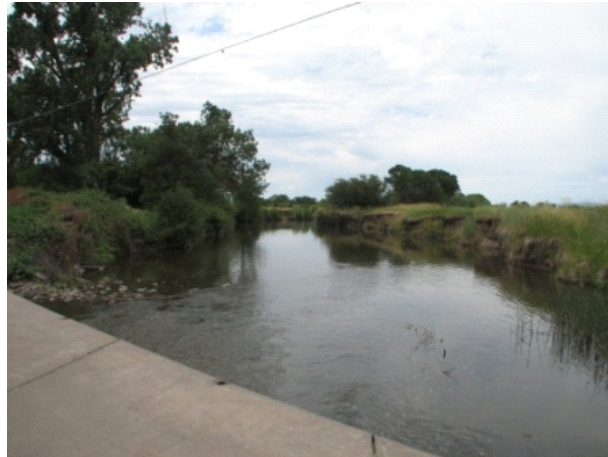
Levee Mile Report Line	1
Start Levee Mile	0.00
End Levee Mile	0.00
Location	
Category	Channels
Item	Vegetation & Obstructions
Downstream at a sharp left bend moderate erosion on both banks	
rduffey_c_20090817_005.jpg

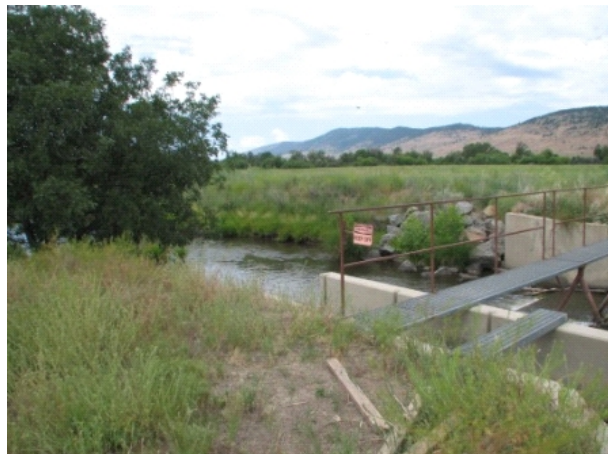
Levee Mile Report Line	1
Start Levee Mile	0.00
End Levee Mile	0.00
Location	
Category	Channels
Item	Vegetation & Obstructions
Dam with fish ladder and metal walkway construction Oct.1999 by Dept. of Fish & Game	
rduffey_c_20090817_006.jpg

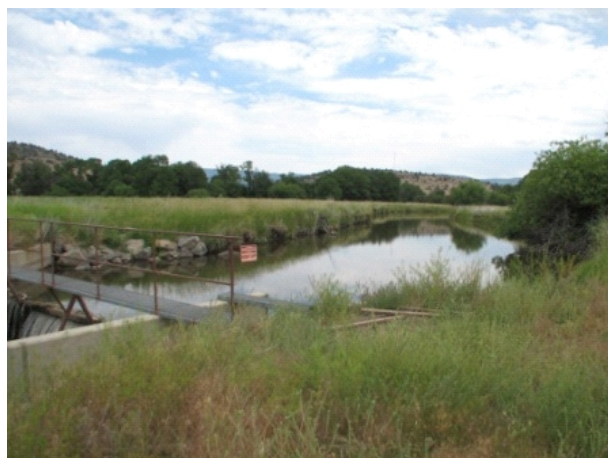
Levee Mile Report Line	1
Start Levee Mile	0.00
End Levee Mile	0.00
Location	
Category	Channels
Item	Vegetation & Obstructions
Upstream from the downstream limit	
rduffey_c_20090817_007.jpg

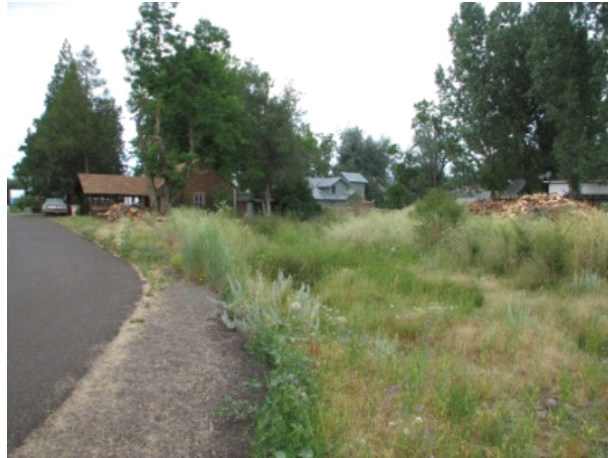
Levee Mile Report Line	1
Start Levee Mile	0.00
End Levee Mile	0.00
Location	
Category	Channels
Item	Vegetation & Obstructions
Downstream at Cedar Street moderate growth in channel	
rduffey_c_20090817_008.jpg

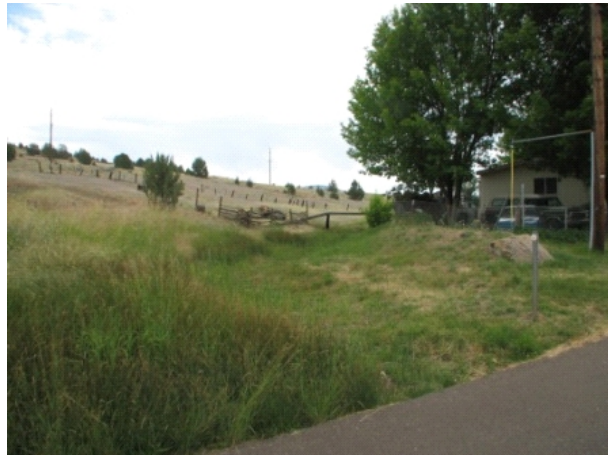
Levee Mile Report Line	1
Start Levee Mile	0.00
End Levee Mile	0.00
Location	
Category	Channels
Item	Vegetation & Obstructions
Upstream at Cedar Street minimal growth in channel	
rduffey_c_20090817_009.jpg

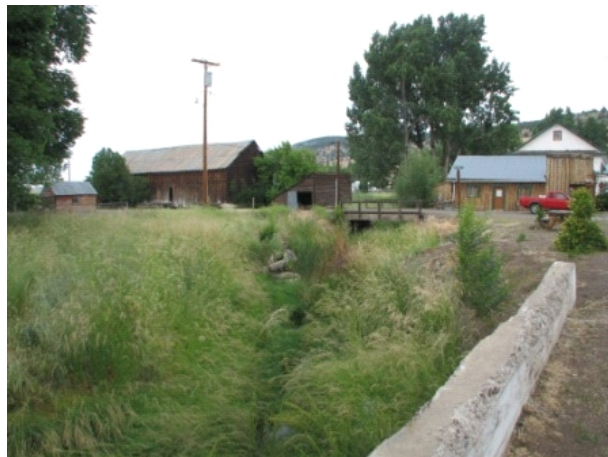
Levee Mile Report Line	1
Start Levee Mile	0.00
End Levee Mile	0.00
Location	
Category	Channels
Item	Vegetation & Obstructions
Downstream from Main Street (Hwy 299) moderate growth in channel	
rduffey_c_20090817_010.jpg

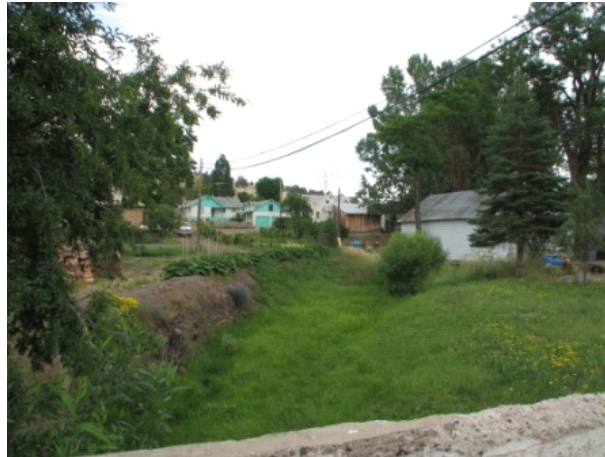
Levee Mile Report Line	1
Start Levee Mile	0.00
End Levee Mile	0.00
Location	
Category	Channels
Item	Vegetation & Obstructions
Upstream from main street (Hwy 299) minimal growth in channel	
rduffey_c_20090817_011.jpg
